LEVEL
VAN DORANS MILL DAM
NJ 00364

PHASE 1 INSPECTION REPORT
NATIONAL DAM SAFETY PROGRAM.

Van Dorans Mill Dam (NJ-00364). Passaic
River Basin, Passaic River, Somerset County,
New Jersey. Phase 1 Inspection Report.

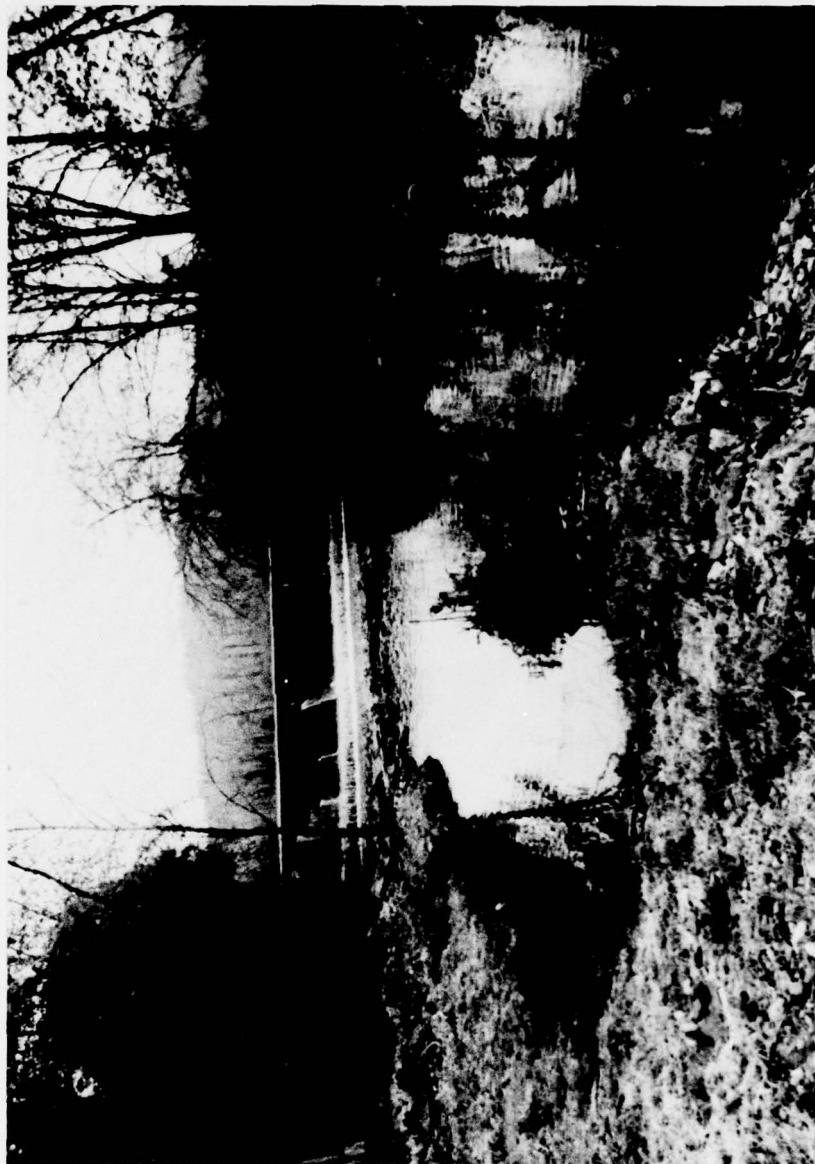
Van Dorans Mill Dam
Overall view of spillway from downstream.

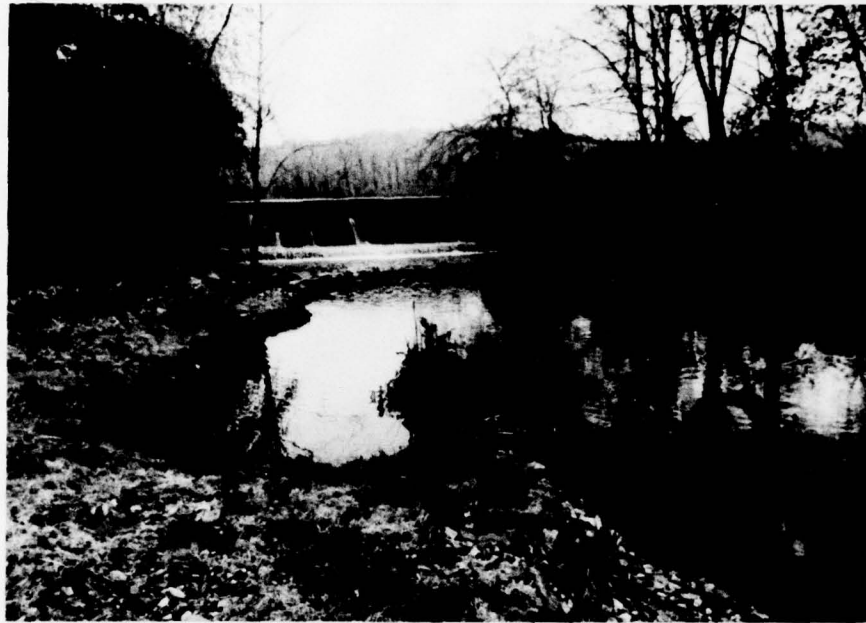
VISUAL EXAMINATION OF	OBSERVATIONS	REMARKS AND RECOMMENDATIONS
VEGETATION	<p>The left embankment was covered with a dense growth of brush and trees. Large trees growing on each side of the spillway are endangering the stability of the rip-rap shoulders.</p>	<p>Remove all brush and trees from embankment.</p>
<p>JUNCTION OF EMBANKMENT AND ABUTMENT, SPILLWAY AND DAM</p>	<p>Severe erosion in the rip-rap covered abutments of the concrete spillway, where it joins the left and right embankments. The left embankment is near ruin. A large tree is growing on each abutment.</p>	<p>Repair and patch abutments with stone and mortar.</p>
ANY NOTICEABLE SEEPAGE	<p>Stagnant water found in two locations at the toe of the left embankment. Heavy vegetation on d/s face made exact detection of seepage difficult, but a constant seepage flow of approximately 5 gpm was noted in a ditch parallel to the toe.</p>	<p>Inspect for possible seepage after removal of trees and brush.</p>

Photo No. 1 - Overall view of spillway from downstream. Note the large trees growing above the rip-rap on both sides of spillway, and the overgrown left embankment.

(4) Remove all trees and brush from the embankments and abutments to avoid problems which may develop from their roots. The entire downstream face should then be inspected for cracks and unusual settlements or loss of fill material and the extent of animal burrowing determined. The downstream face should then be repaired where required, and the animal burrows filled. Add rip-rap protection to the upstream face.

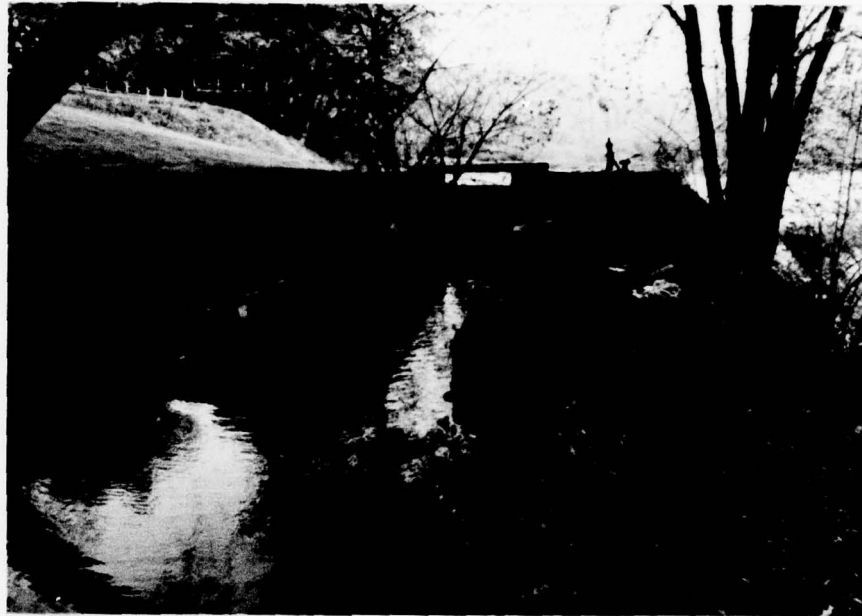
Photo No. 3 - View of mill-stream to the right of the spillway. The picture shows the control sluice and the footbridge.

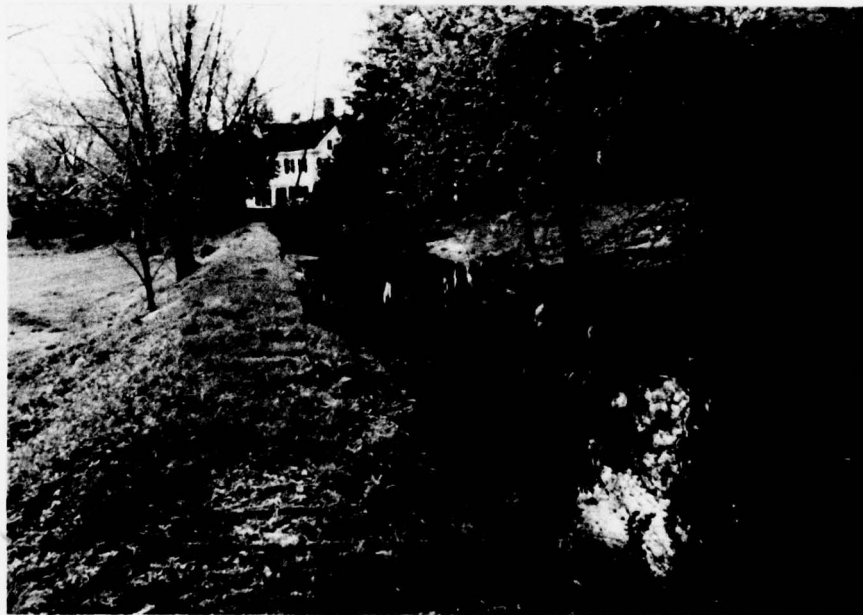
Photo No. 4 - Downstream view of mill-stream showing artificial embankment.

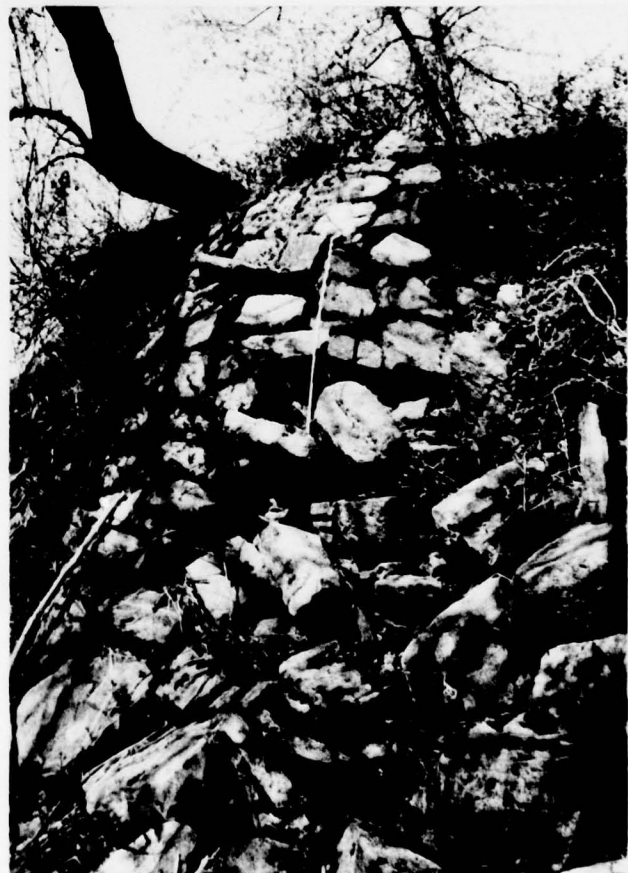
The left spillway abutment is more severely eroded than the right spillway abutment. The downstream face of the embankment has many deep animal burrows and some seepage seems to be occurring through the embankment. Undermining of the spillway toe also presents a potential hazard.

Photo No. 6 - Detail of deteriorated rip-rap at left end of spillway. Note the dangerous condition of the tree.

(2) Provide concrete underpinning at the toe of the spillway abutments. In the right abutment, replace missing stones with concrete and repoint existing stones. Rebuild the left abutment.

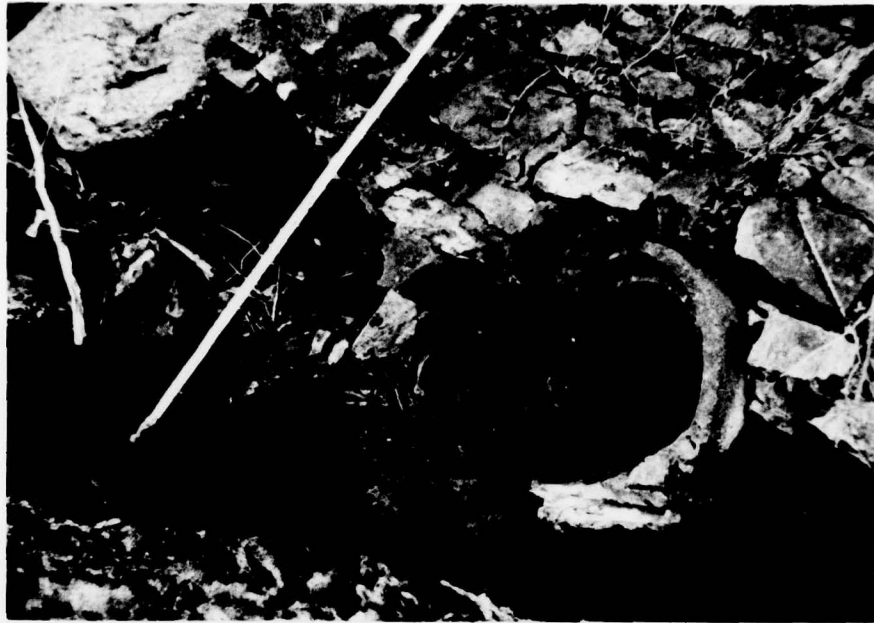
A 24 inch diameter concrete pipe outfall exists at the base of the right abutment. The inlet to the pipe is upstream of the dam and may be silted up. The sliding control gate is located on the upstream side of the right embankment, adjacent to the spillway. It is housed in a masonry wet well shaft with a wooden cover. The sliding gate's operating mechanism is missing, rendering the outlet inoperable. Because of the depth of water in the shaft, it could not be determined if the gate was still in the chamber. A small leakage was observed at the downstream end of the outlet pipe, but it was not possible to determine if blockage of the outlet pipe was due to the sliding gate or to silting up in the reservoir.

Photo No. 7 - Detail of low-level outlet discharge. Note the minor leakage, and the missing blocks of rip-rap around the pipe.

(1) A safe means of lowering the lake should be provided. This would involve restoring the existing outlet pipe to operable condition. The owner should also consider providing additional low-level outlet facilities.

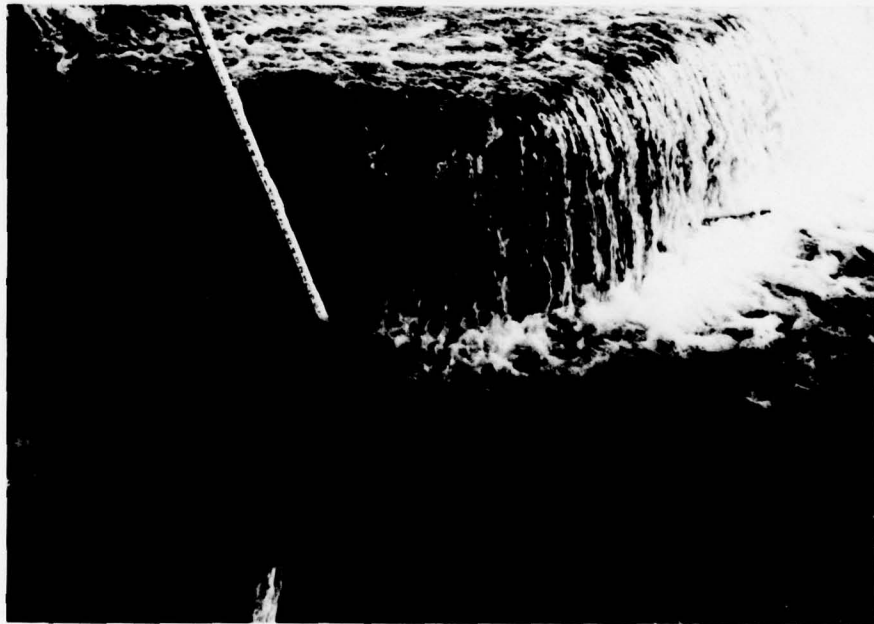
The surface of the ogee is spalled and contains some transverse cracks. The concrete spillway apron also has some cracks and the right downstream corner is chipped off, exposing reinforcement.

Photo No. 8 - Detail of broken section of concrete at right toe of spillway.

(3) Repair the concrete surface and apron of the spillway structure, using epoxy concrete and reinforcing where required.

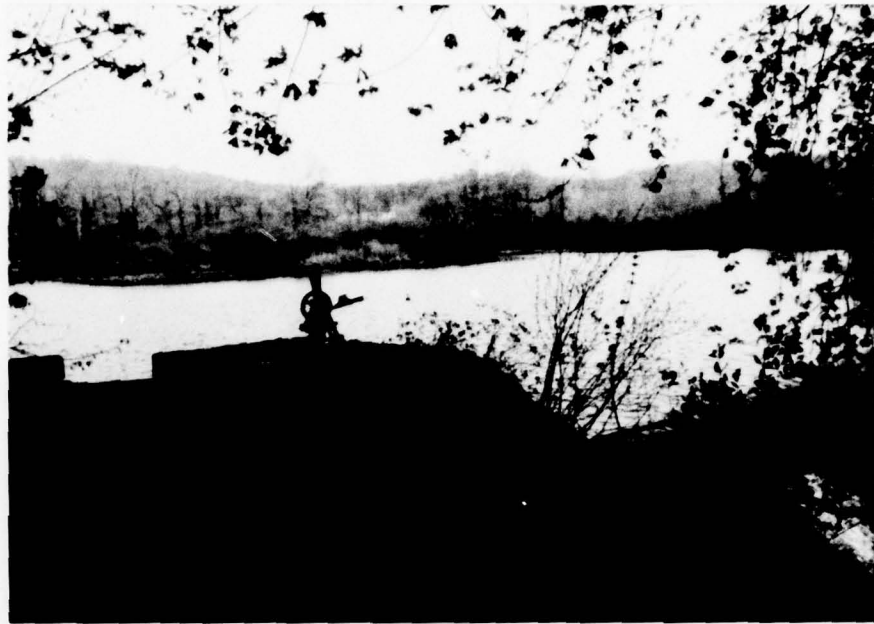
Photo No. 11 - View of the reservoir looking upstream from the foot-bridge. Note the moderate slopes and weed growth around rim. The well containing the control valve for the low-level outlet can be seen in the foreground.
